NATIONAL PROGRAM FOR INSPECTION OF NON-FEDERAL DAMS
ASSABET RIVER DAM (MA.) (U) CORPS OF ENGINEERS WALTHAM
MA NEW ENGLAND DIV DEC 79

ASSABET RIVER DAM

OVERVIEW
ASSABET RIVER DAM
WESTBOROUGH, MASSACHUSETTS

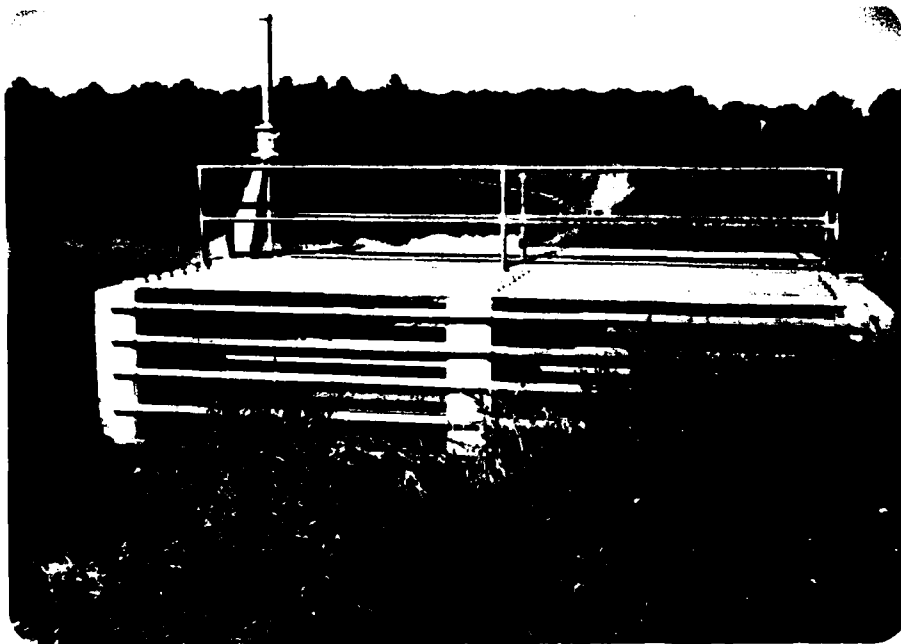
- 4.3 Maintenance of Operating Facility. The operating mechanism at the dam is the sluice gate on the low-level outlet. This gate is operated by the SCS personnel during their annual inspection. The condition of the trash racks around the outlet structure (see Photo No. 1 in Appendix C) is also reported and maintenance performed as required.

NO. 1 OUTLET WITH TRASH RACKS AT SPILLWAY
